# **Assessing Built-up Areas in Flood zones of the Teesta Basin in the Sikkim Himalaya**

**Sikkim University**

**Degree of Master of Philosophy**

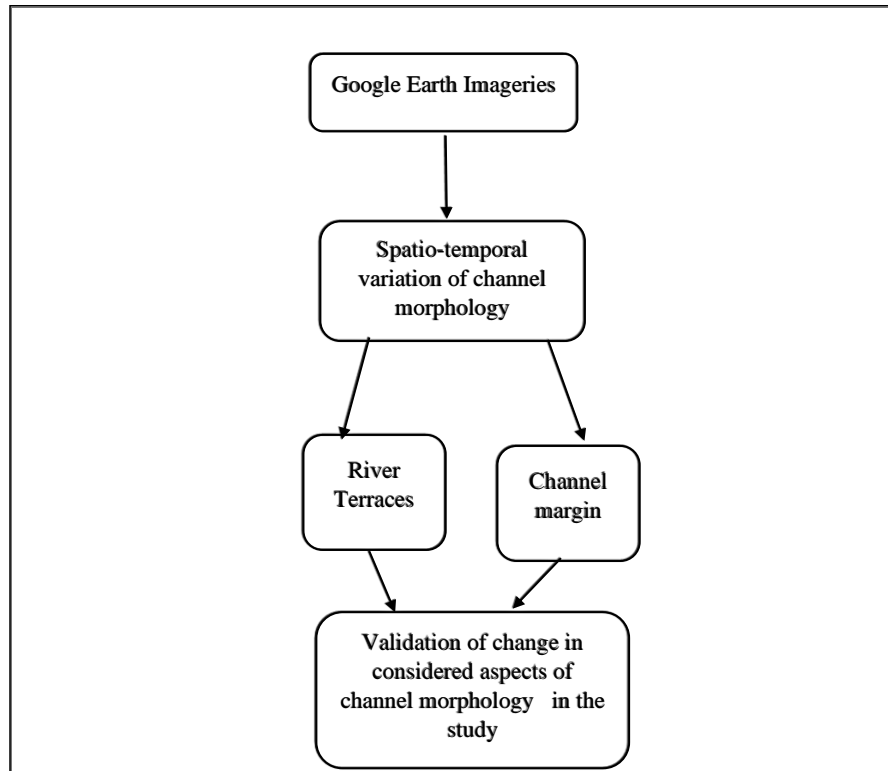
*Figure 2.2. Flow chart of methodology*

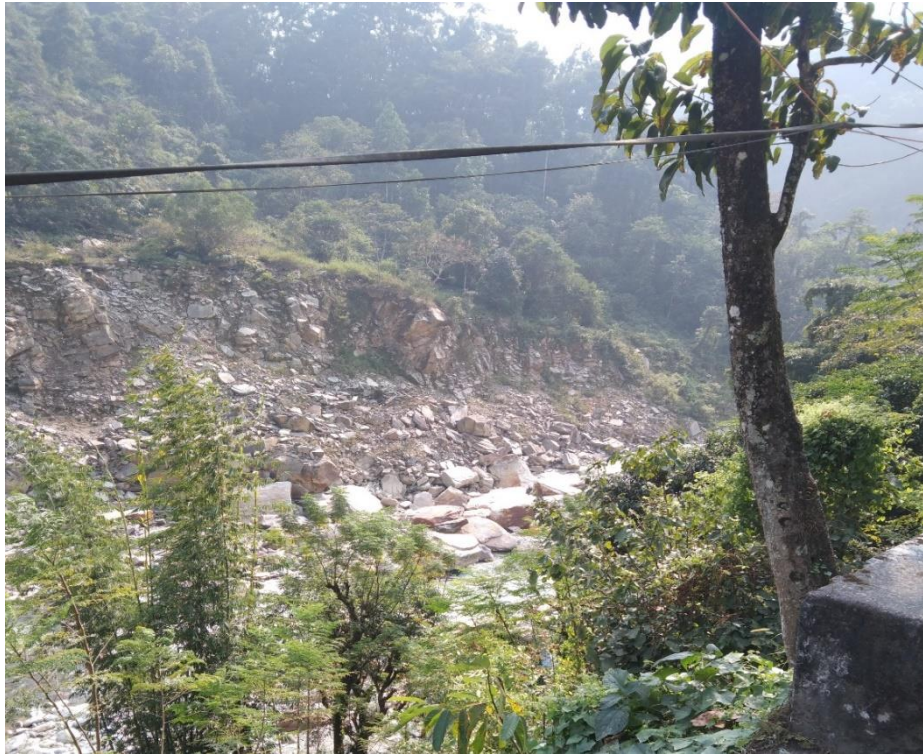
**Figure 2.5.** Bank failure in the Rangit at Legship area (27.279 N 88.277 E)

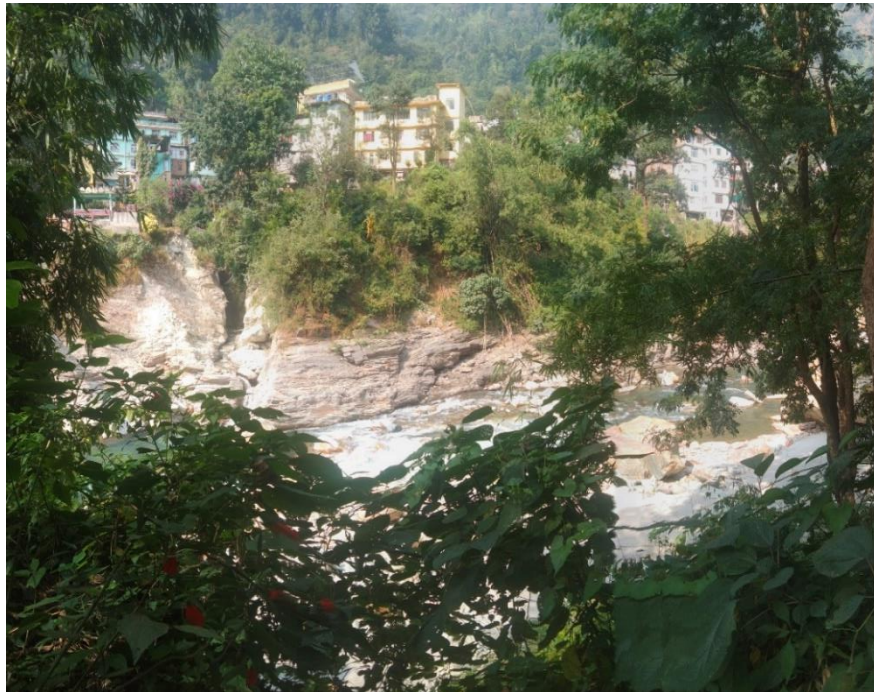
**Figure 2.6.** Erosion of Mid-level terrace in the Rangit at Legship area (22.279 N 88.275E)

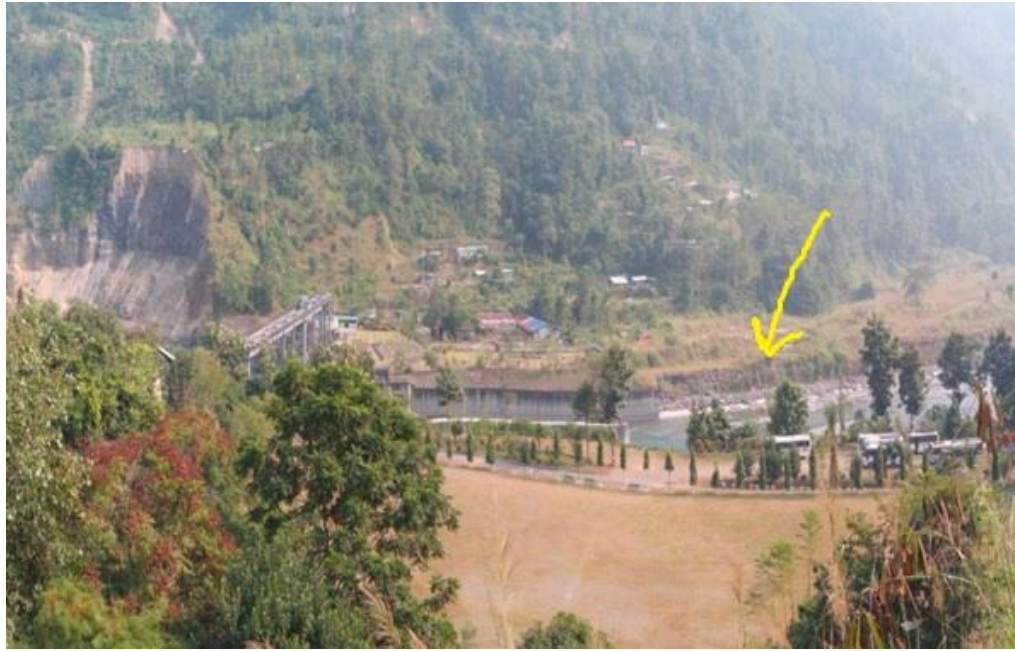
**Figure 2.7.** Erosion of lower terrace downstream of Jorethang Loop HEP in the Rangit at Rothak area (27.164 N 88.296 E)

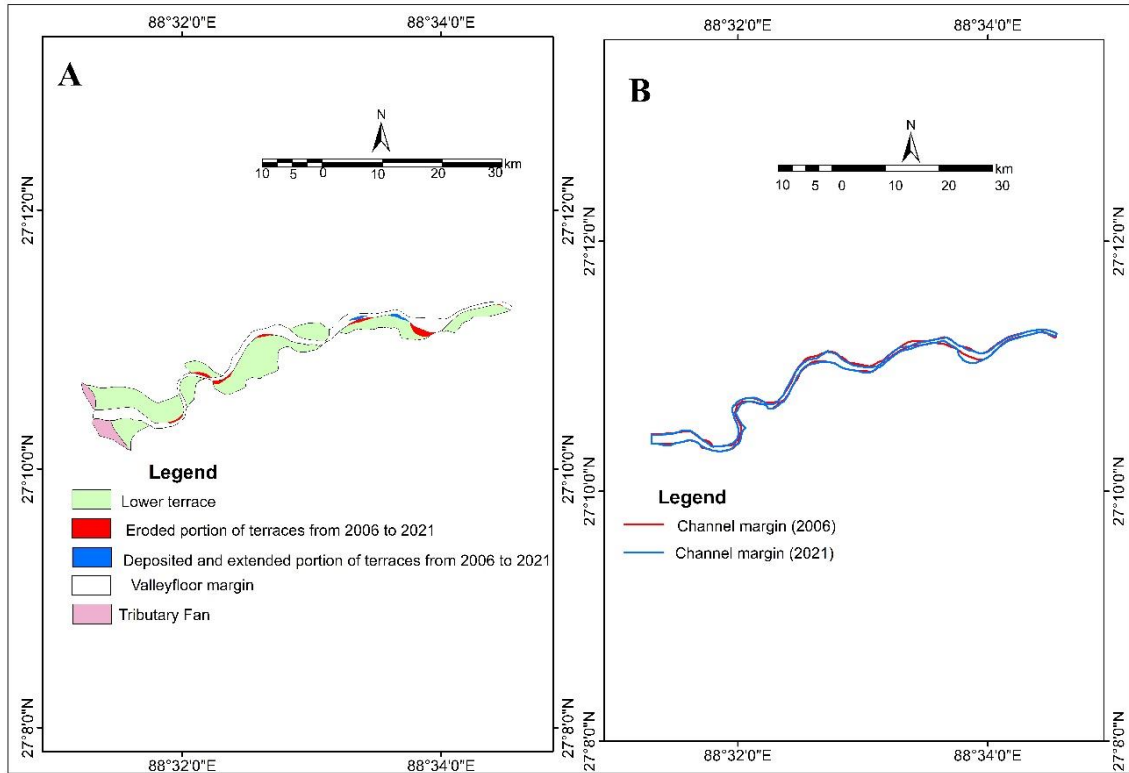
**Figure 2.9.** (A): Change of terrace morphology; (B): Change of channel margin of the selected stretch of the Rangpochu between 2006 to 2021

Rangpochu reach (Figure 2.9) is wide, semi-confined, and possesses good scope of lateral adjustment mainly during high flood flow as the major portion of the considered

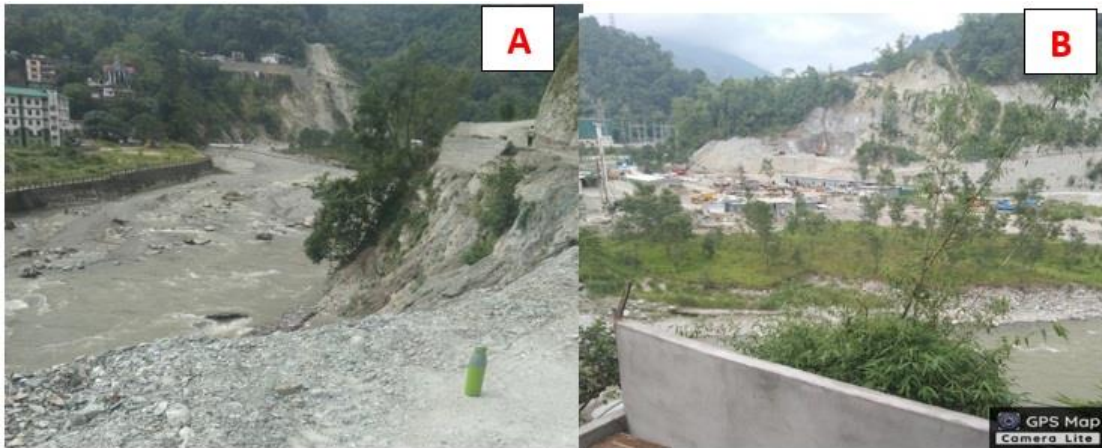
**Figure 2.11.** (A): Slope failure at the selected stretch of the Rangpochu due to landslides (27.13 N, 88.533 E) (B): Lateral Shift of lower terrace at the Rangpochu due to erosion ( 27.176 N, 88.532 °E)

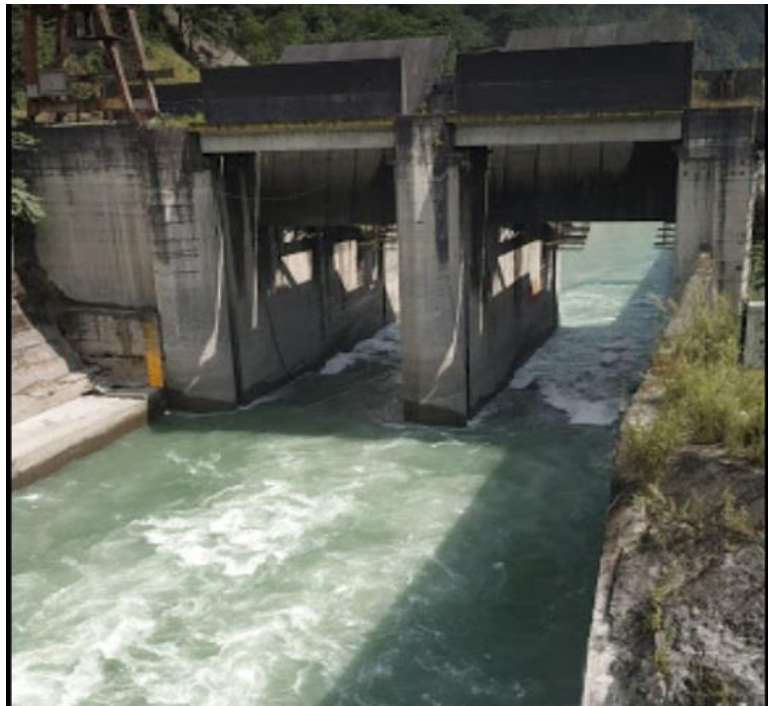
**Figure 2.12.** Teesta IV dam upstream of Singtam causing diversion of river channel.

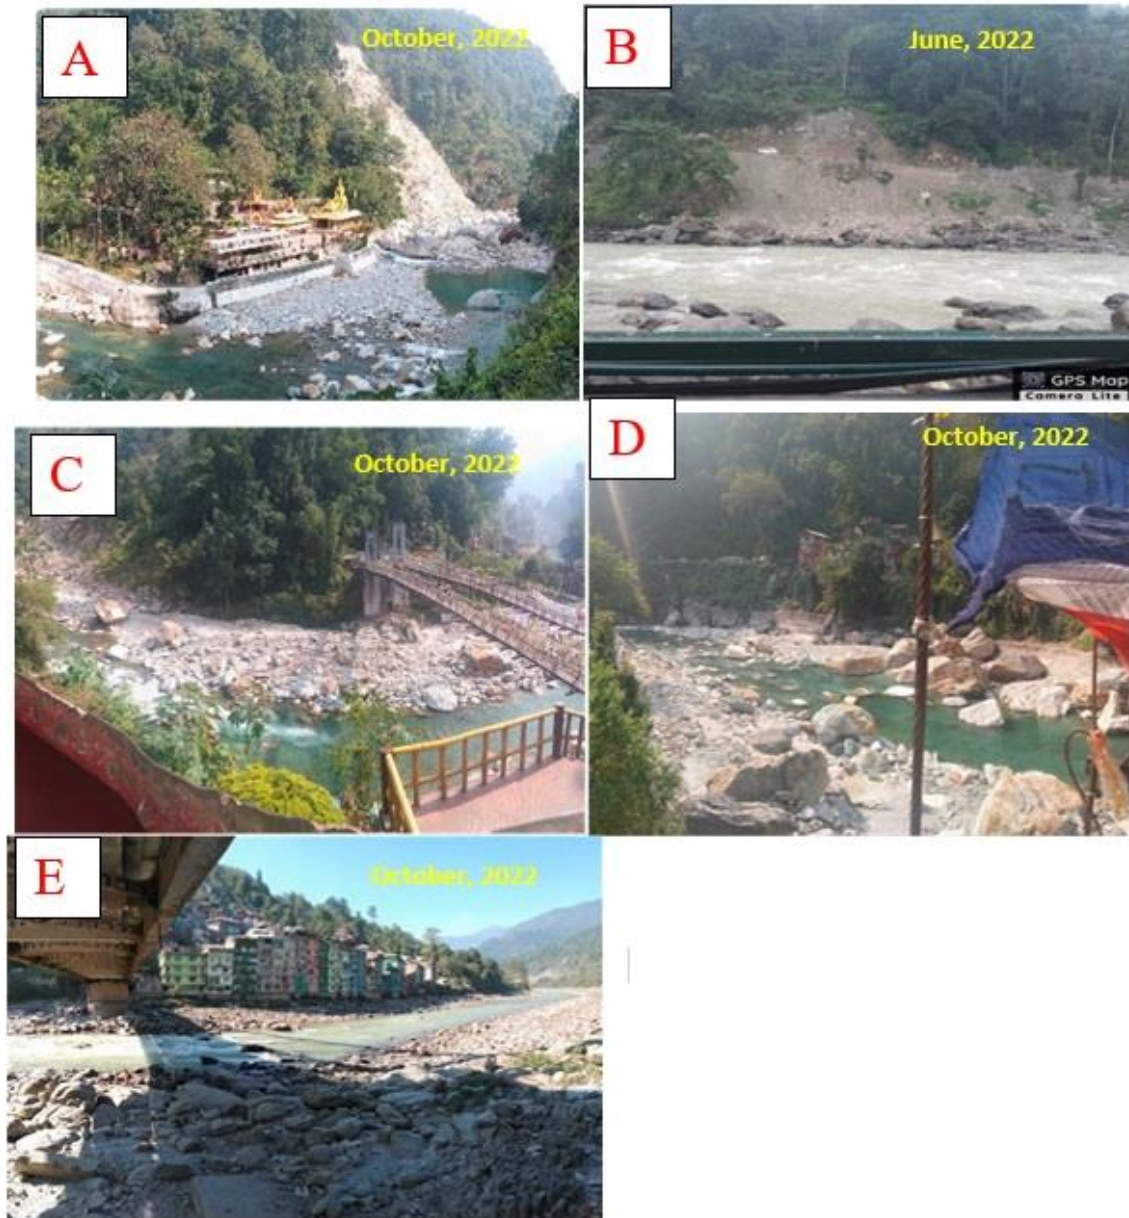
**Figure 2.15.** (A): Landslides as a source of sediments in the Rangit at Legship area (27.278 N 88.277 E). (B): Sediment supply from road construction in the Teesta at Singtam bazar area (27.229 N 88.492 E). (C): Sediment carried down and deposited by October 2021 flood in the Rangit at Legship area (27.278 N 88.276 E). (D): Massive boulders deposited by October 2021 flood in the Rangit at Legship area (27.277 N 88.275 E). (E): Massive accumulation of sediments in the Teesta river at Singtam bazar area over the period (27.231 N, 88.492 E)

supply of sediments due to bank failure, water-carried sediments and boulders and landslides (Figure 2.16).

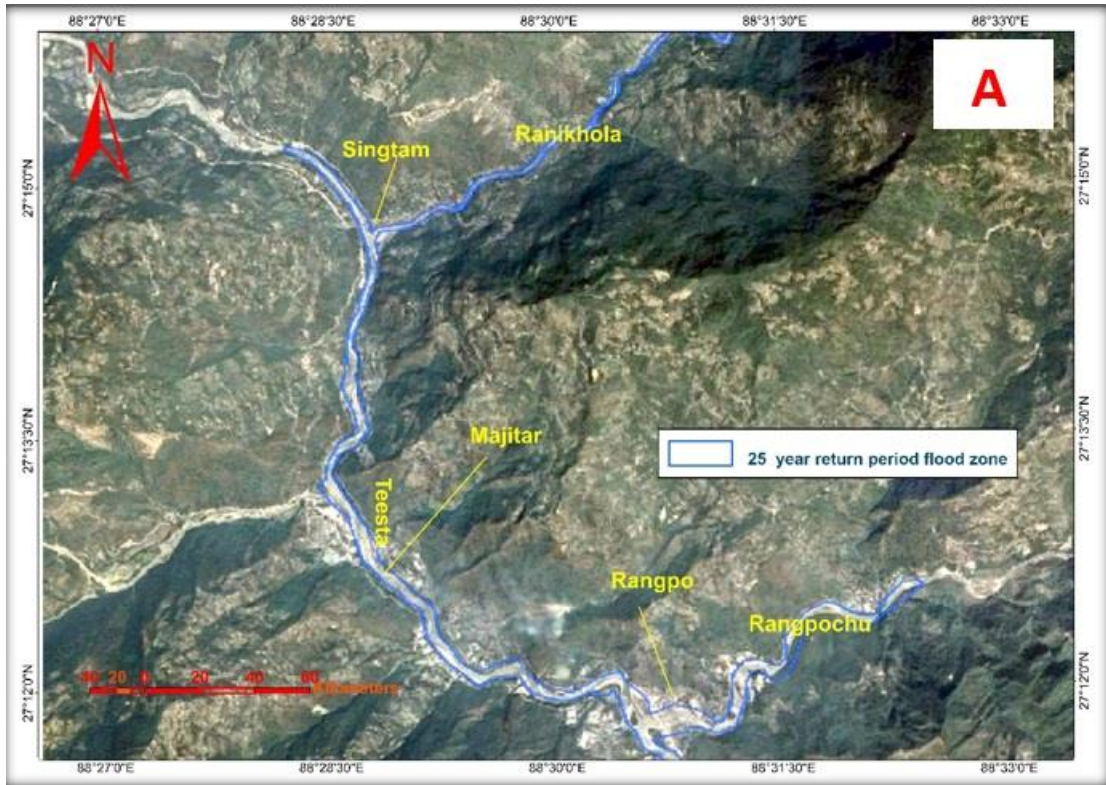
**Figure. 3.7 (A):** Flood zone of 25year return period flood in the selected stretches of the Teesta, Ranikhola and Rangpochu

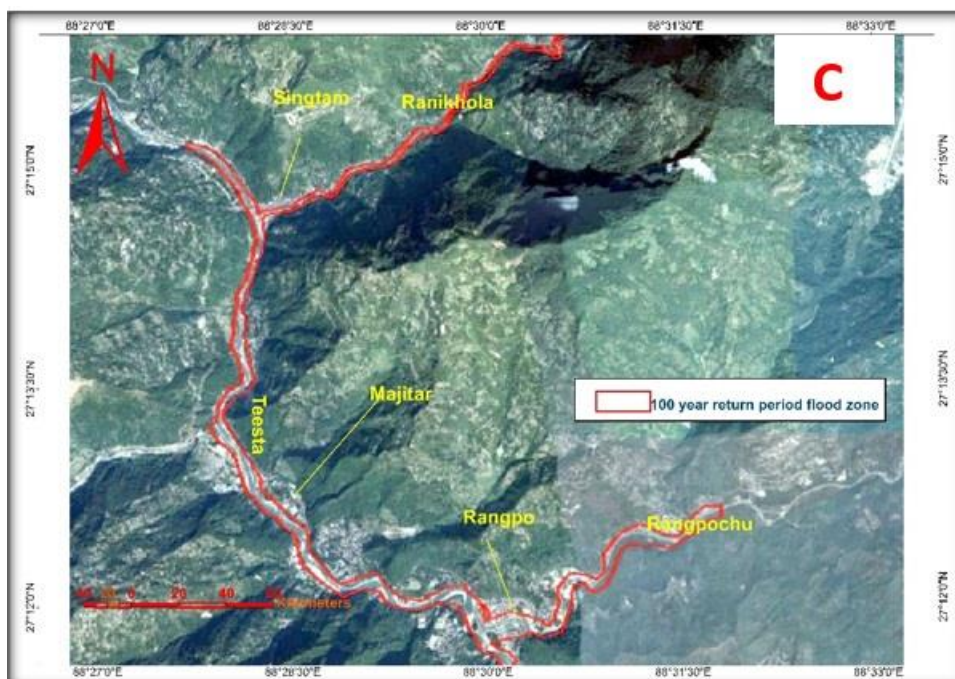
*Figure 3.7. (C): Flood zone of 100-year return period flood in the selected stretches of the Teesta, Ranikhola and Rangpochu*

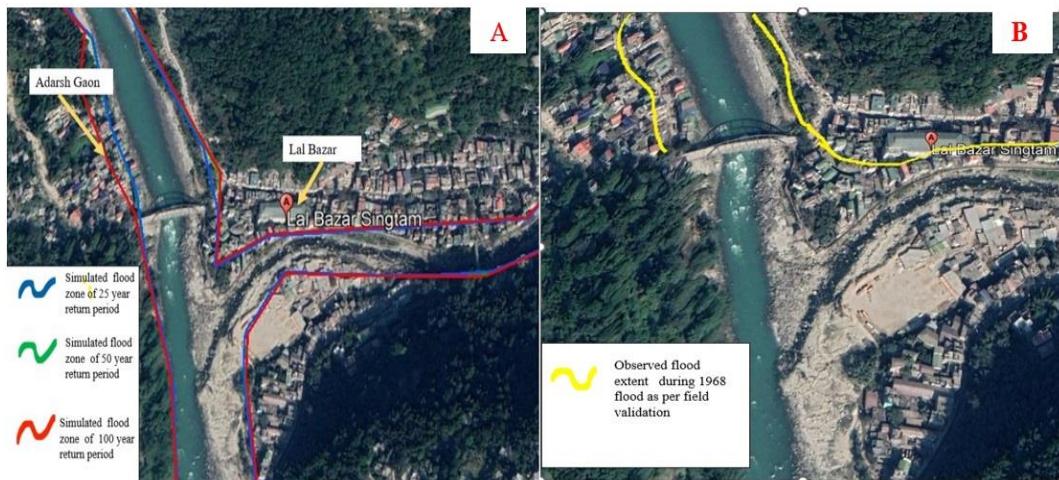
**Figure 3.15.** (A): Simulated flood zone of 25, 50 and 100-year return period flood at Singtam bazar (B): Observed maximum flood zone at Singtam in October, 1968.

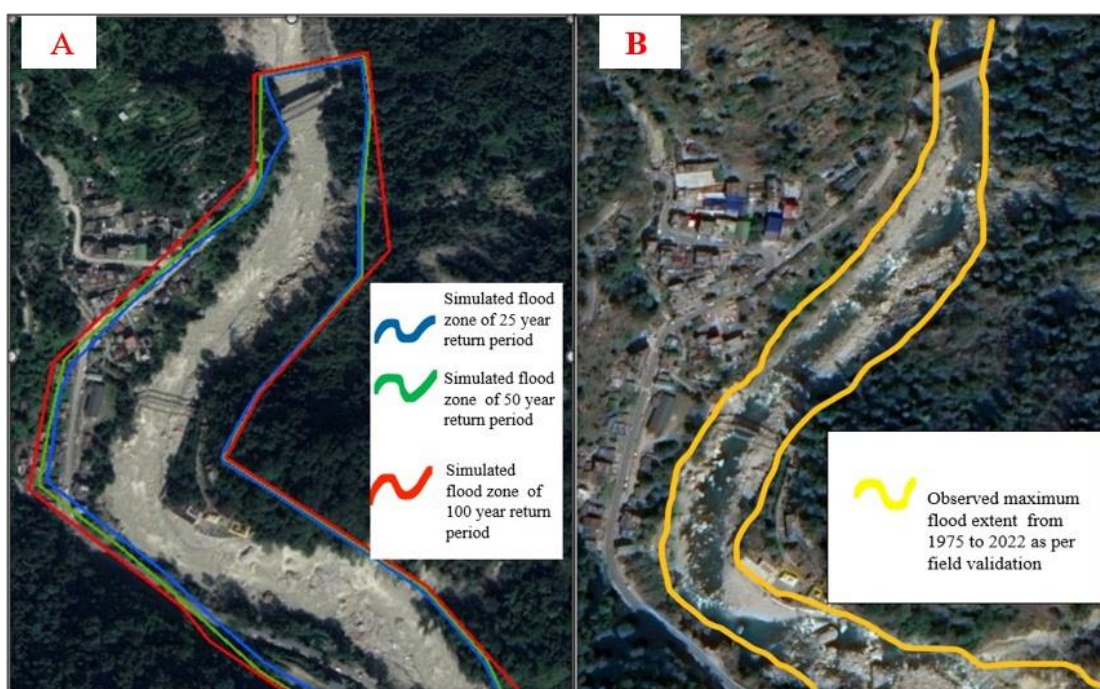
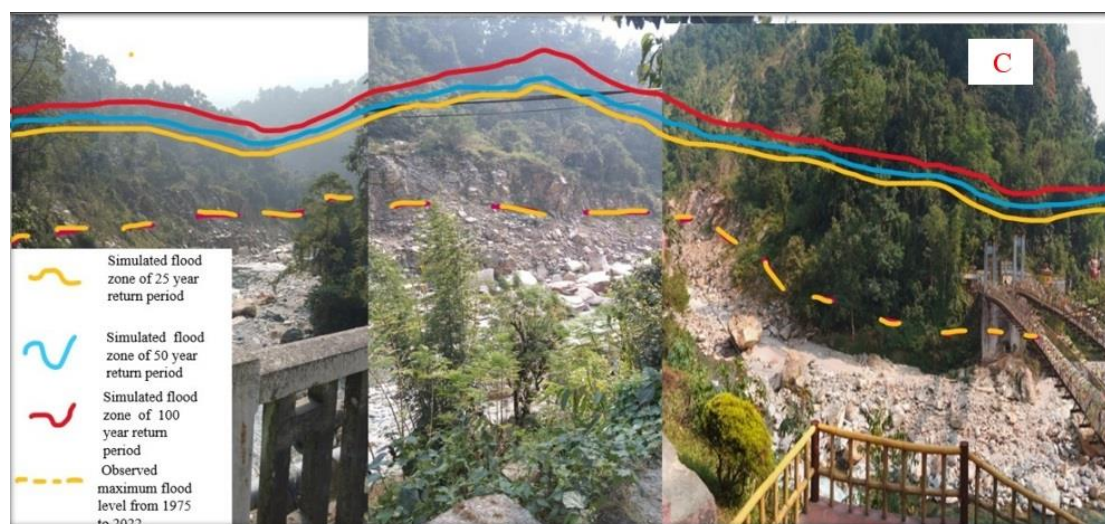
**Figure 3.16.** (A): Simulated flood zone of 25, 50 and 100-year return period flood at Legship Bazar area. (B) and (C): Observed maximum flood zone at Legship bazar area (1975 to 2021).

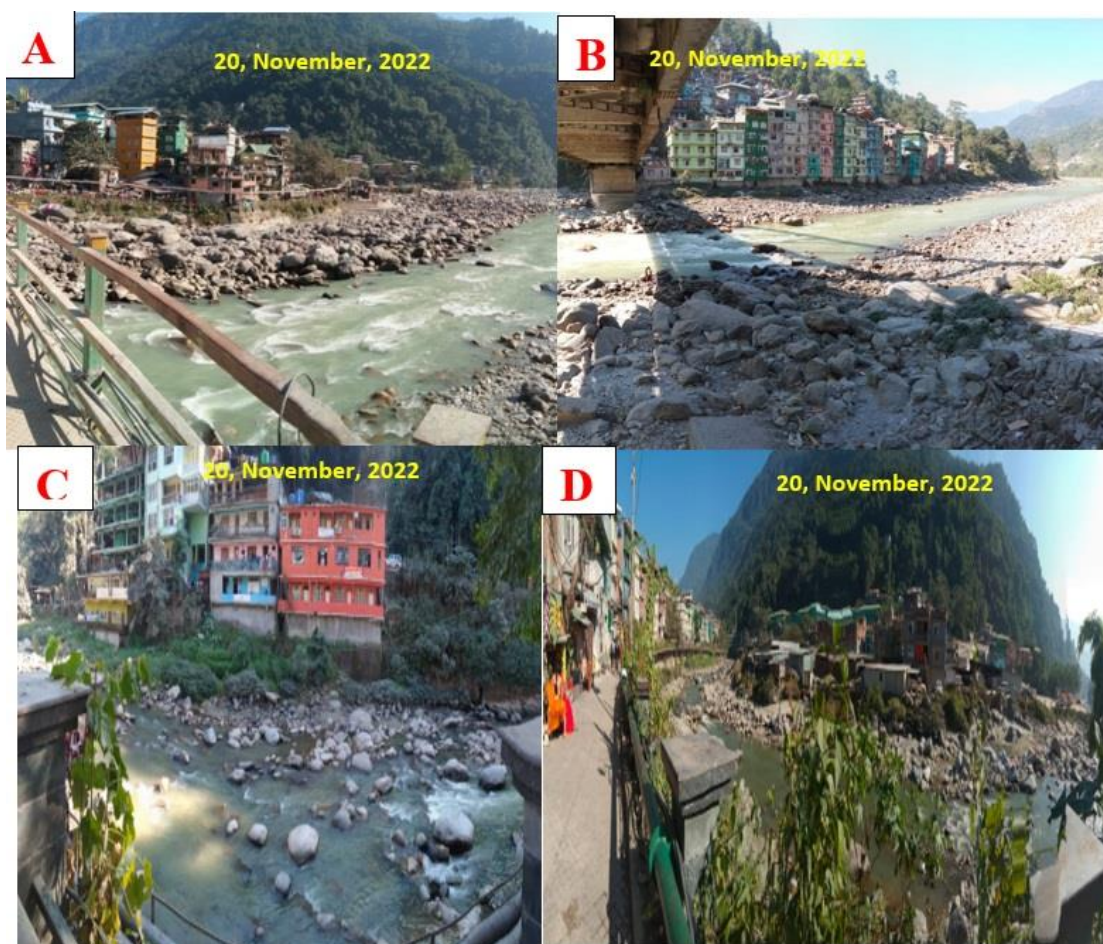
**Figure 4.1.** Built-up area in (Grid 6) along the Teesta and Ranikhola. (A): Built-up area downstream of Indreni pool part of which currently gets inundated during monsoon season (27.231 N, 88.492 E). (B): Built-up area upstream of Indreni pool (27.233 N, 88.49 E). (C): Built -up area on right bank of the Ranikhola ((27.231 N, 88.499 E). (D): Built – up area at the confluence point of the Ranikhola with Teesta (27.23 N, 88.499 E).

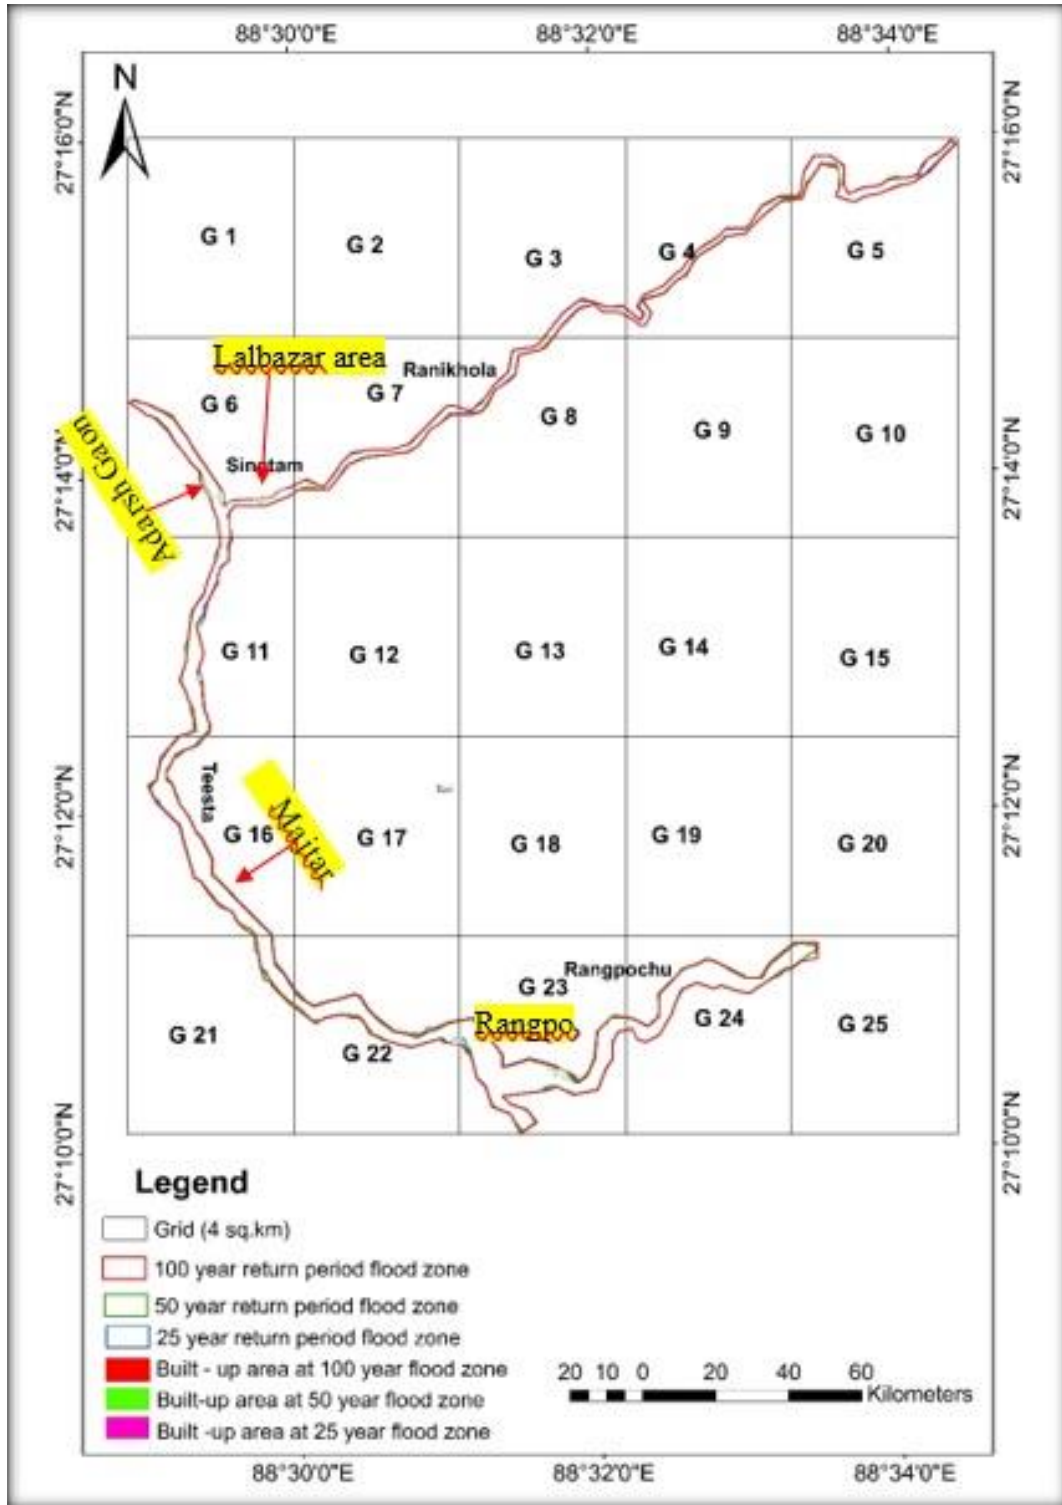
*Figure 4.2. Built-up areas within the flood zones of 25, 50 and 100-year return period in the selected stretches of the Teesta, Ranikhola and Rangpochu in the year 2006*

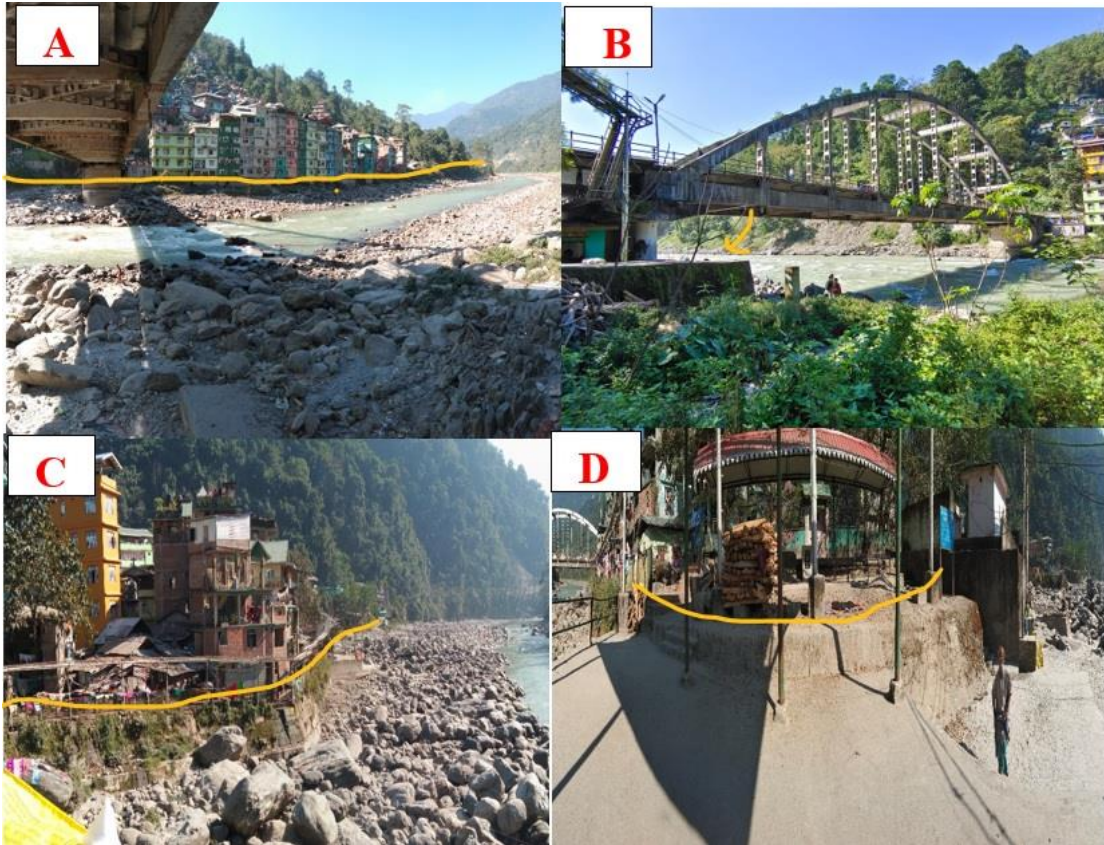
**Figure 4.4.** Water level overflowing embankments at **A:** Adarsh gaon(27.23N 88.49E); **B:** Lalbazar side (27.231 N, 88.492 E); **C:** Lalbazar side (22.23 N 88.49 E); **D:** confluence point of Teesta and the Ranikhola (27.23 N, 88.498 E)

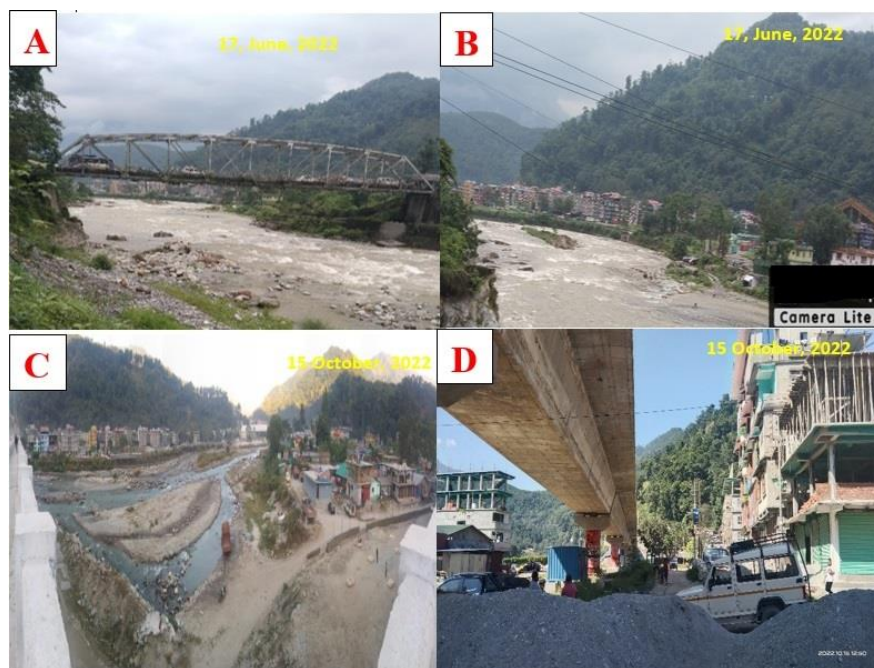
**Figure 4.5.** Built-up area in (Grid 23) along the Rangpochu (A): Rangpo bridge at the borderline of Sikkim and West Bengal which got cracked during heavy discharge flood in Oct 2021 (27.174 N, 88.53 E). (B): Built-up area downstream of Rangpo bridge (27.174 N, 88.529 E). (C & D): Built-up area at the confluence point of the Rangpochu and the Teesta (27.173 N, 88.524 E)

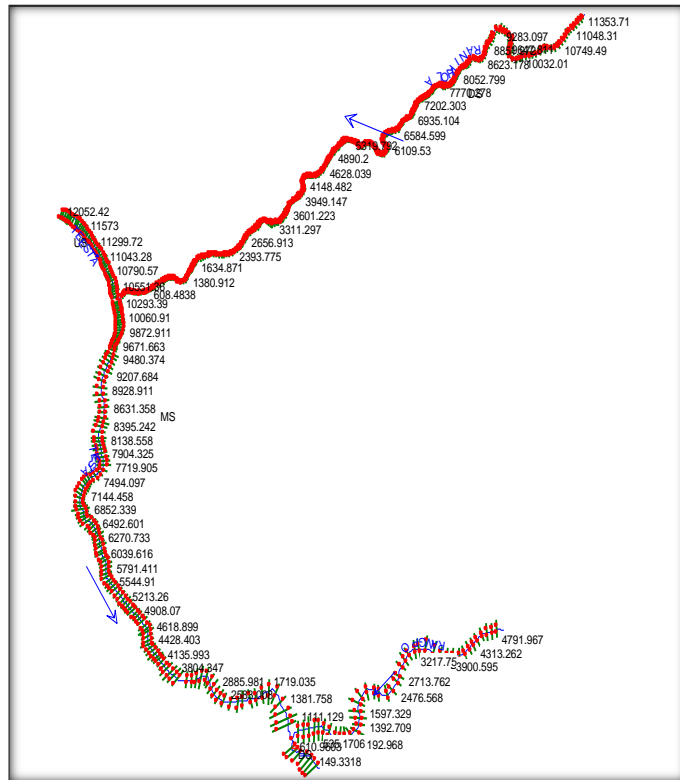
**Appendix I. Geometry file of the selected stretches of Teesta, Ranikhola and Rangpochu for running HEC-RAS 1 d steady flow**

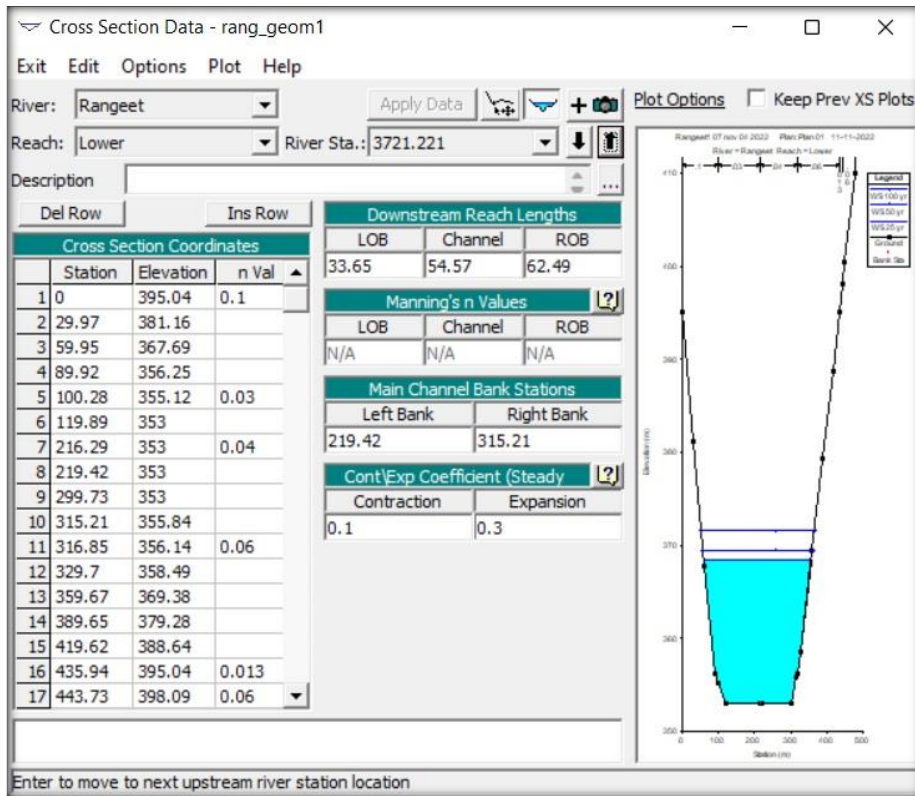
*Appendix VI. Cross section at Rothak area along the Rangit*
